Lessons Learned

Shattered Glass Flask

April 2024

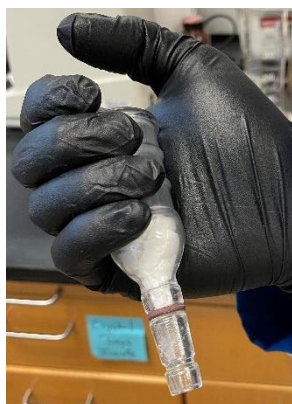
Glass adapter:

The glass flask used in the procedure shattered from the force used to install a glass adapter.

Please refer to the following photos illustrating the recommendation on how to handle laboratory glassware properly:

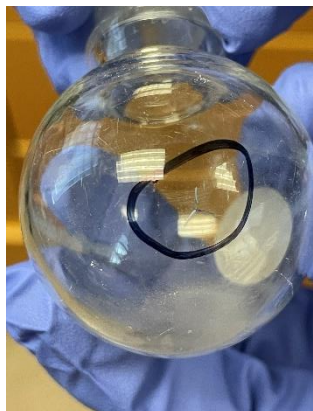
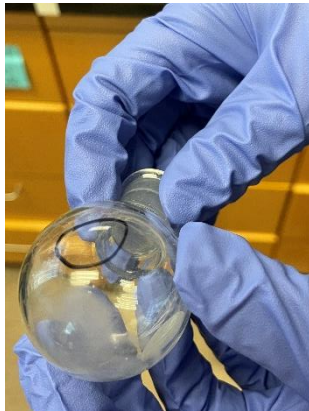
“Starred” glassware:

It is sometimes not easy to recognize a small crack (“star”) in glassware. Note the circled areas on the photos below:

The researcher did not react to his observation of damaged glassware or check for cracks / other defects in the flask. He did not stop the rotavap and utilize another undamaged flask for the procedure.
